JO-1 hose-end swivel inspection recommendations

SMAC-1 hose-end swivel inspection recommendations

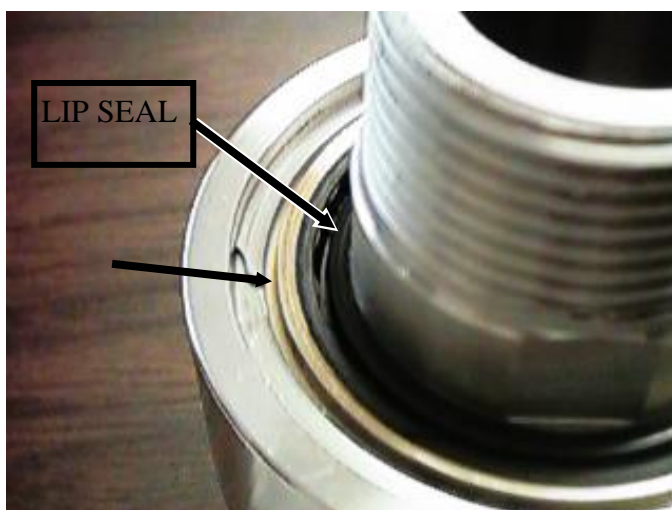
Normal retaining ring seat (note the distance between the inside diameter of the retaining ring and the shoulder of the bearing retainer plate)

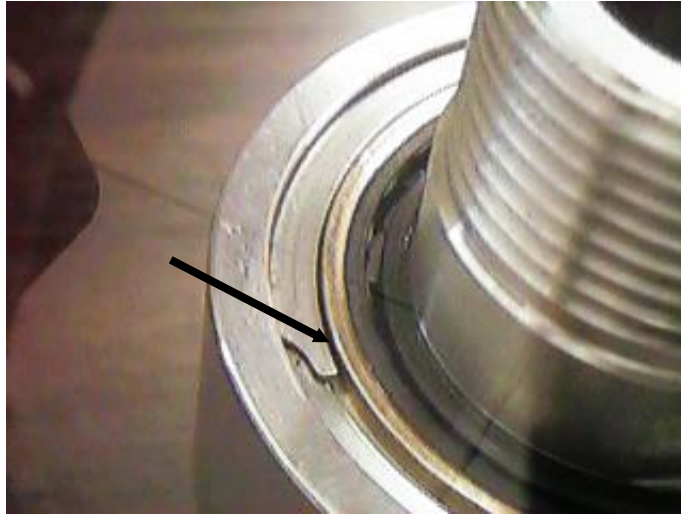
3.) Retaining rings in factory shipped JO-1 swivels are 100% inspected to ensure a proper fit. Because the retaining ring is deeply recessed into the end of the swivel, it would be highly unusual for the ring to become dislodged from its groove. However, proper fit should be checked periodically. Check the retaining ring at the male end of the swivel to ensure it is properly seated. Note the photographs below show a normally seated retaining ring and abnormally seated retaining ring. If the retaining ring appears to be abnormally seated, do not try to reseal the retaining ring while the swivel is installed and the system is under pressure. Remove the swivel from service and follow all directions as outlined in manuals CS-JO1 and IS-JO1. The retaining ring cannot be reseated properly unless the swivel is taken out of service and pressure is applied, such as putting the swivel in a vice and gently tightening the vice jaws. This relieves tension on the retaining ring, allowing for proper seating in its groove.

Abnormal retaining ring seat (note the minimal distance between the inside diameter of the retaining ring and the shoulder of the bearing retainer plate)-take out of service

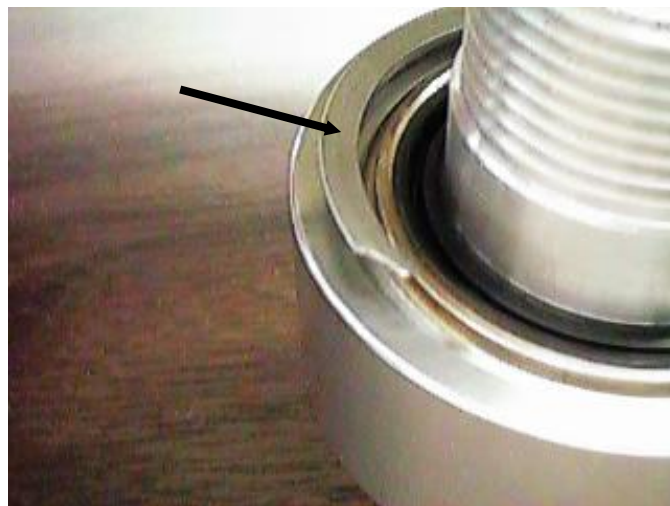
Abnormal retaining ring seat (note the retaining ring tang has come out of the retaining ring groove)-take out of service

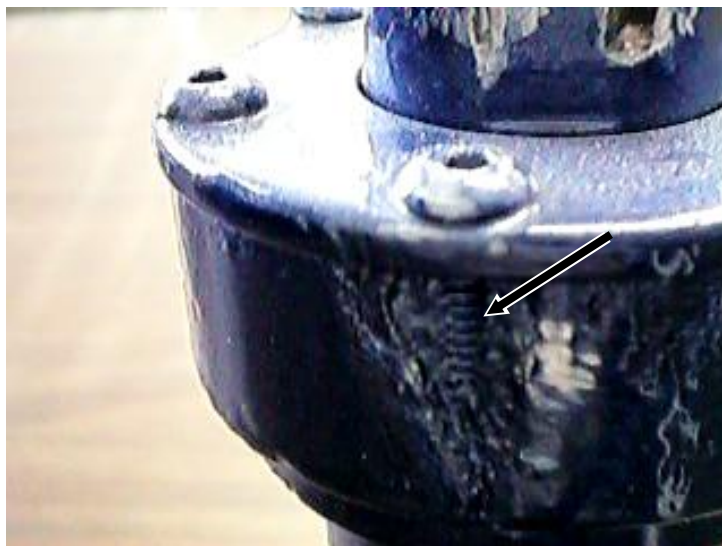
- 1.) The main housing used for the SMAC-1 is fabricated from an Aluminum alloy. In certain geographic areas, especially severe winter areas, corrosion of the main housing may be accelerated principally due to chemicals applied to roads to melt snow and ice. Cleaning chemicals may also be a factor. Visually inspect the outside of the SMAC-1 main housing to look for corrosion damage. This could be in the form of a scaly, flaky appearance, or a white powdery appearance. It is normal for the main housing to take on a light to dark gray appearance. Pay close attention to any apparent corrosion damage such as described above in the vicinity of the Drag Guard™ safety plate that is held onto the main housing with Button-head Allen screws. If noticeable corrosion damage is found, take the swivel out of service.

Note the corrosion, exposing one of the Button-head Allen screws-**take out of service**

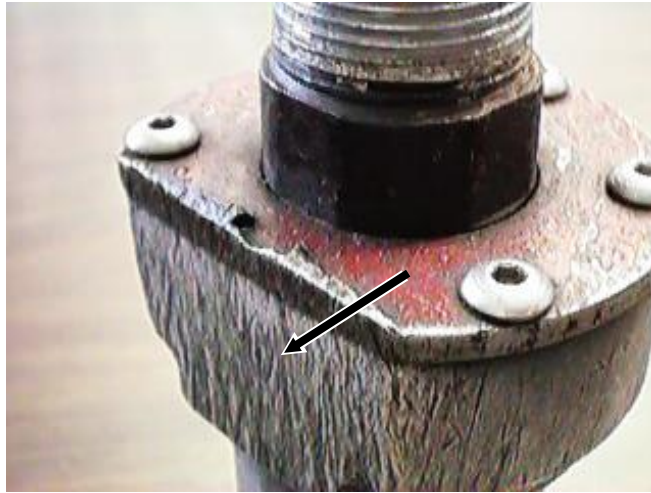
- 2.) The entire swivel can be subject to damage from dragging along the ground. Sustained dragging, such as, but not limited to the delivery hose being inadvertently dragged behind a moving delivery truck, will cause severe damage, generally to one side of the swivel. Inspect the outside of the swivel for areas that are worn flat. If one or both sides of the swivel are worn flat, take the swivel out of service. If any of the Button-head Allen screw heads are ground off, take the swivel out of service.

Note the flat-sided wear due to dragging behind a delivery truck-**take out of service**
